**Figure 1.** Aerial photograph of Rich Inlet, Figure Eight Island and Hutaft Island depicting conditions as of 11/9/08. Note the expansive marginal flood channel located on the F8I margin that acts as a corridor for the transport of large volumes of sand into the estuary and interior channels. Also note the developing spit along the F8I inlet shoreline. Photograph courtesy of GBA- Wilmington, NC.

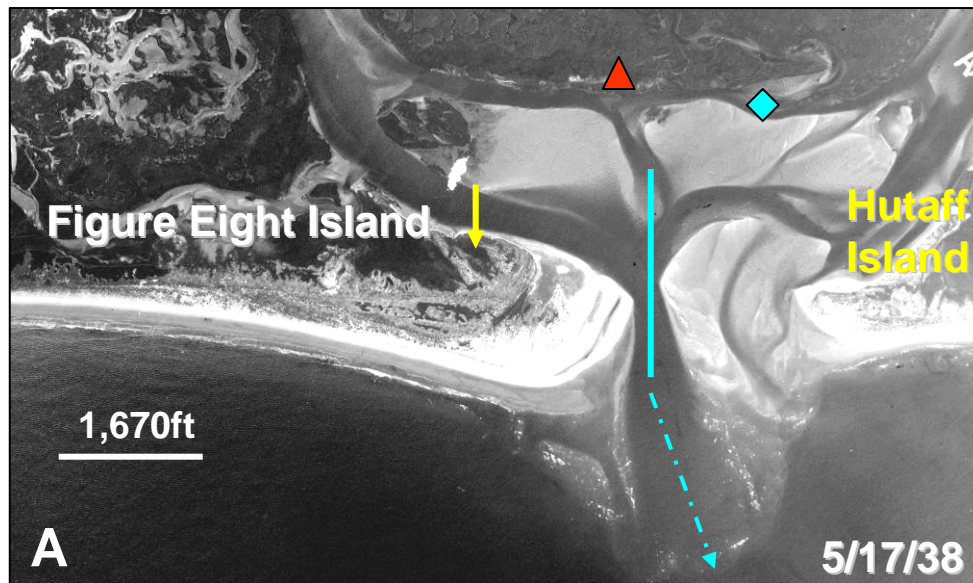
**Figure 16.** Historic aerial photographs (1938 – 1959) illustrating shoreline changes along F8I downdrift of Rich Inlet. **A.** View (5/17/38) of the north end of F8I showing accretion zone downdrift of Rich Inlet. **B.** View (1/23/45) of the erosion along the accretion zone. Note truncated dune ridges and the encroachment of the flood channel due to the skewed ebb channel. Also note the progradation of the HI shoreline. **C.** View (11/20/49) depicting the skewed ebb channel and the buildup of the shoreline in the lee of the flood channel. Note the erosion of the HI oceanfront. **D.** View (8/16/59) showing progradation of the F8I oceanfront and inlet margin accretion (spit buildup). The erosion of HI is due to the NE shift of the ebb channel and development of the flood channel. Red triangle and light blue diamond are reference points.

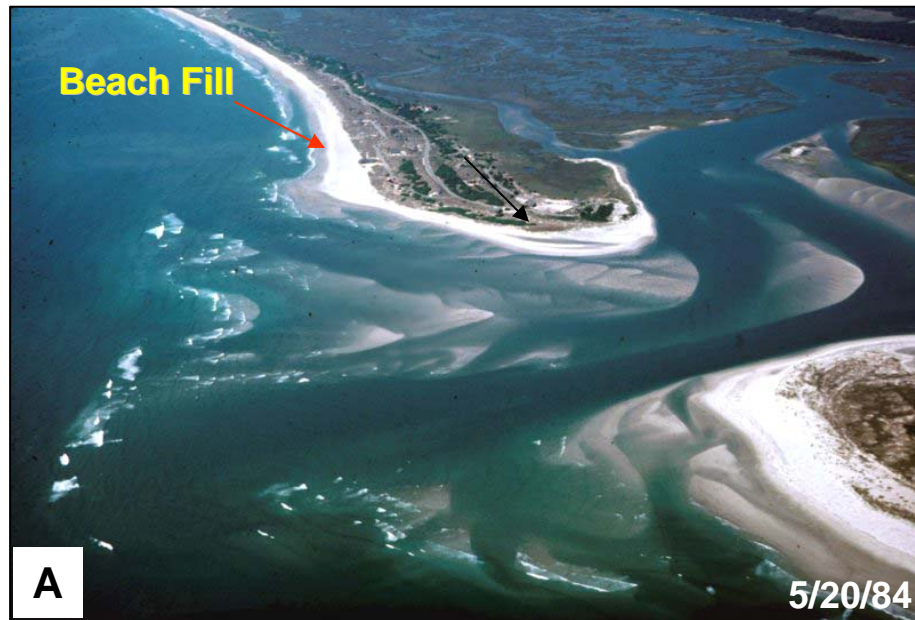
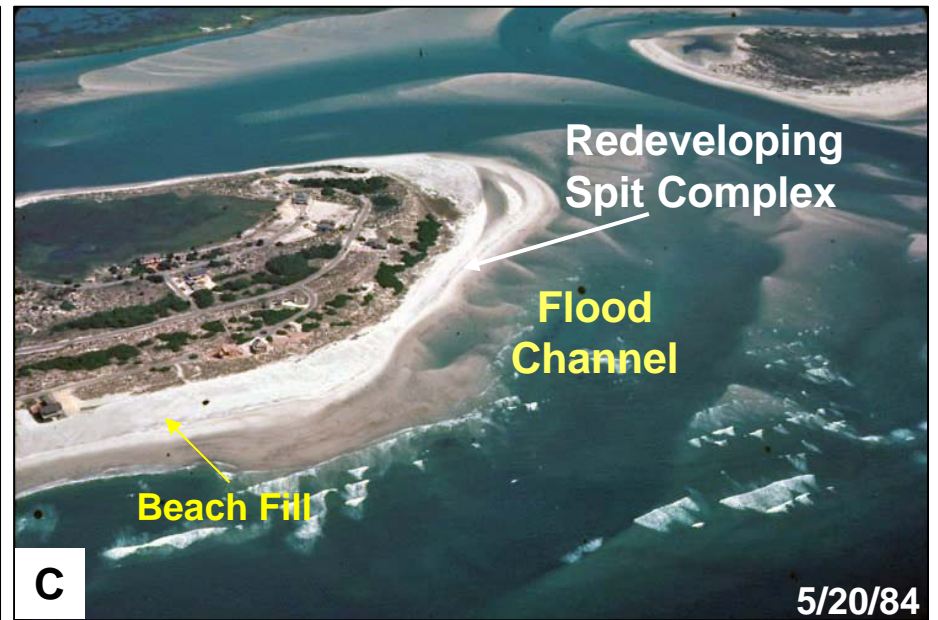
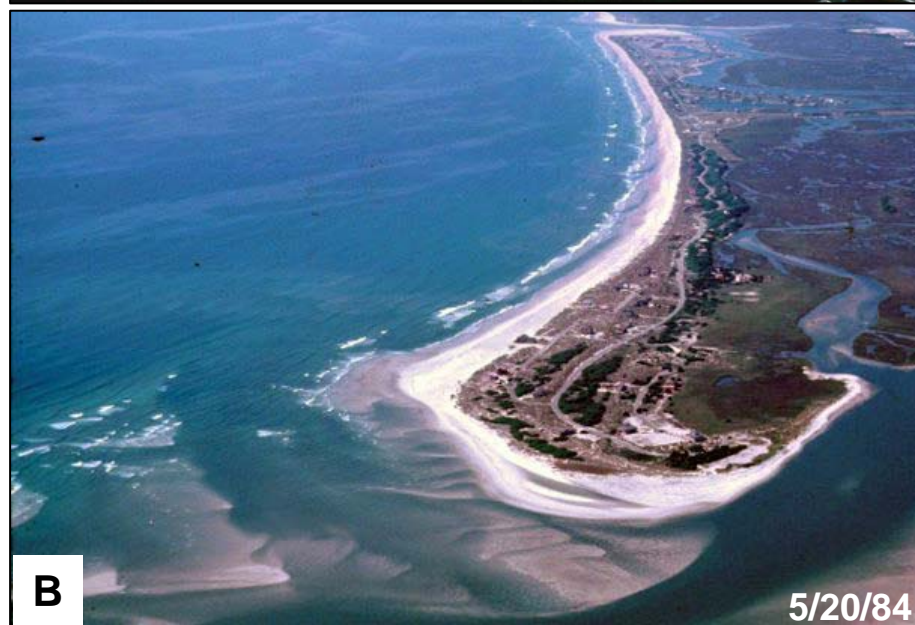
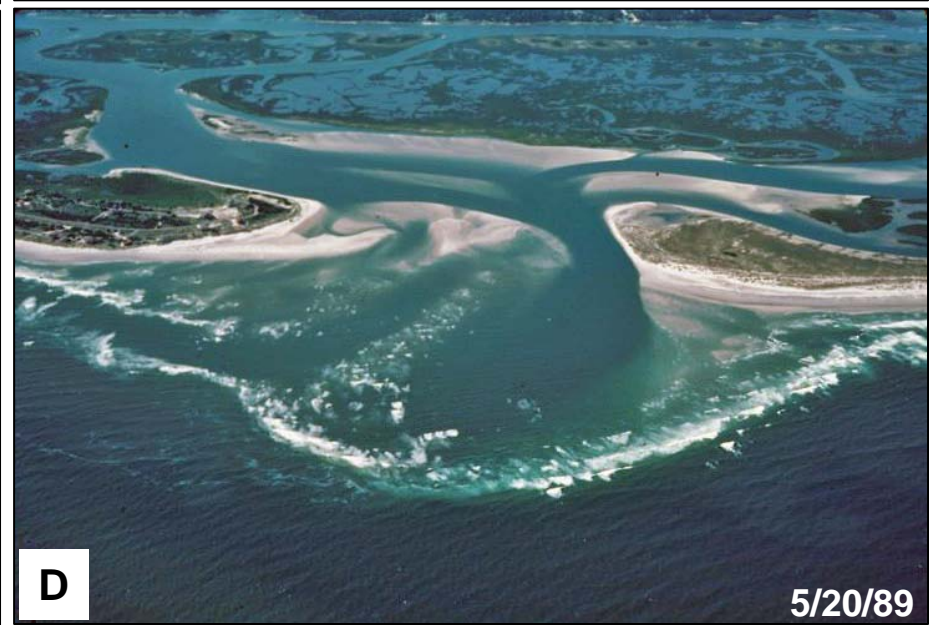
**Figure 18.** Aerial photographs depicting condition of nourished oceanfront shoreline prior to mid 1984 erosion episode. **A.** and **B.** (5/20/84). Views of nourished shoreline segment and swash bar welding onto F8I. **C.** View (5/20/84) showing the onset of erosion of redeveloping inlet shoreline **D.** Landward view (5/20/89) of Rich Inlet showing spit development along scarp inlet shoreline. Note lack of shrub line along scarp line.

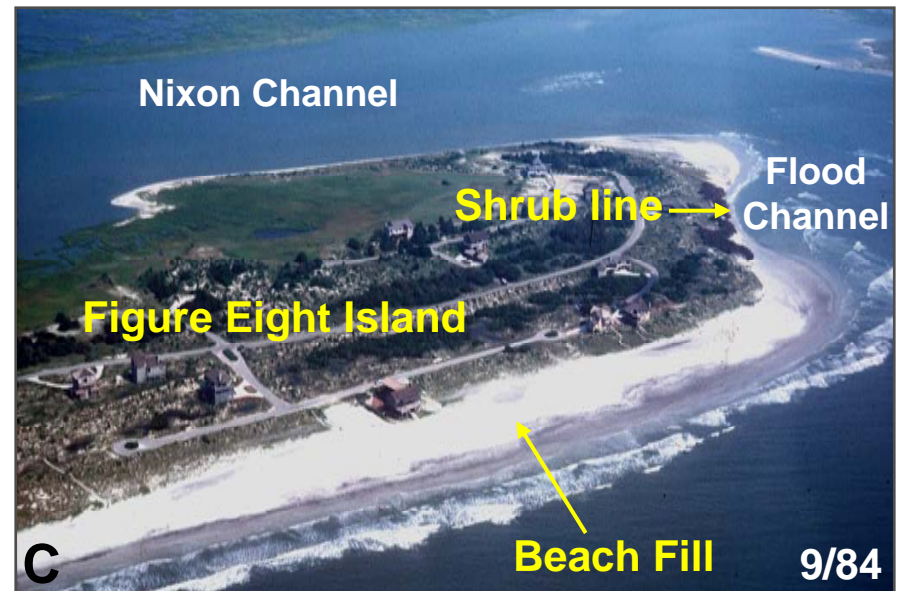
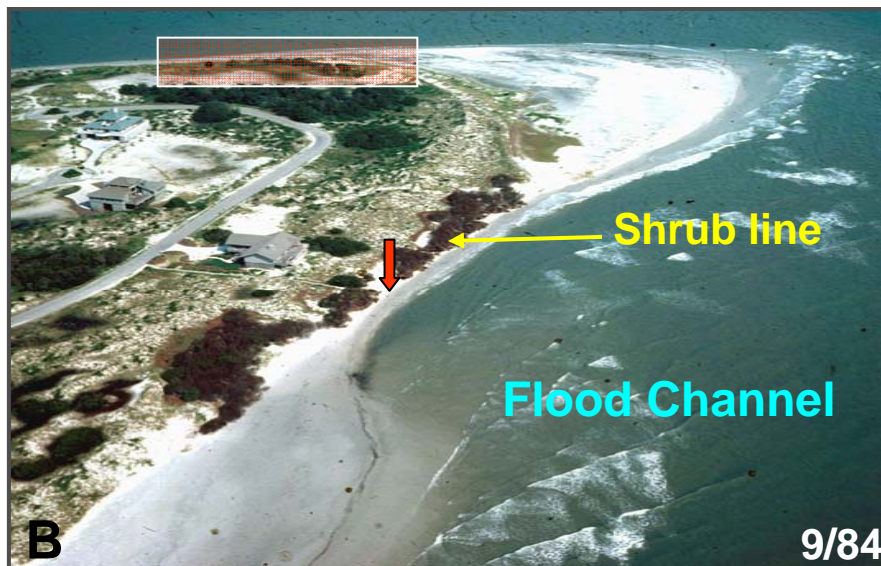
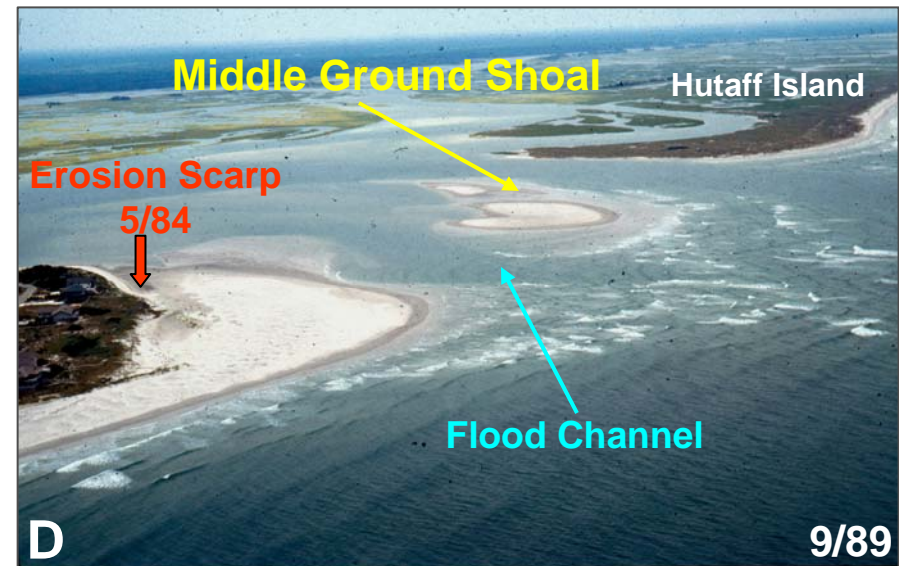
**Figure 19.** Oblique aerial photographs of F8I and Rich's Inlet shoreline during 1984. **A.** Seaward view of the inlet shoreline depicting the redeveloping spit, ridge and swale features, and the intact shrub line. **B.** Oblique aerial photograph depicting very rapid erosion of the inlet shoreline and dying shrub thickets. Compare to "A". **C.** Landward view (9/84) of eroded and scalloped inlet shoreline. **D.** Landward view (9/89) of rebuilt and elongating inlet shoreline spit. Note the occluded channel adjacent to the scarped uplands and the lack of shrubs. By 1993 the spit had enlarged considerably and the flood channel had infilled while the mid-inlet shoal became incorporated into the barrier.

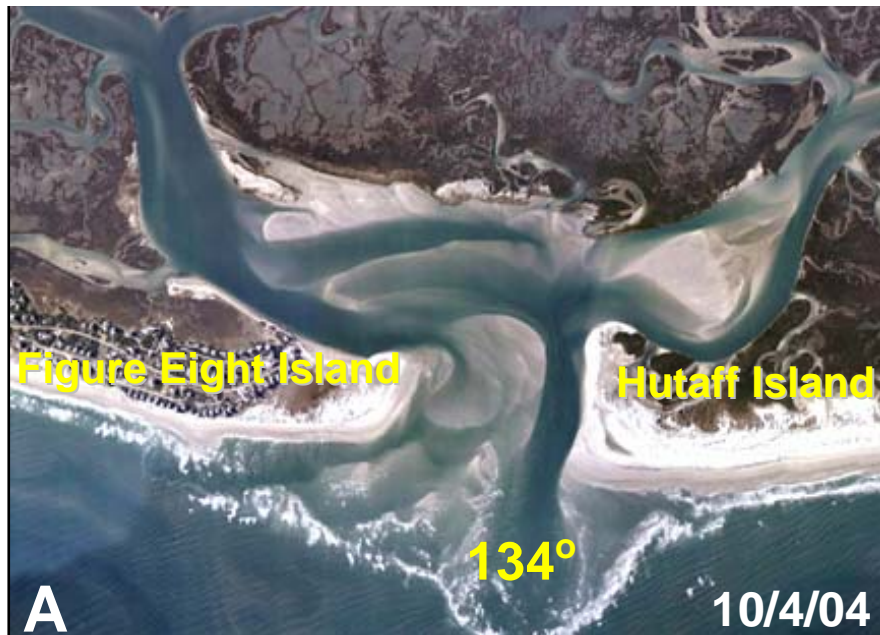
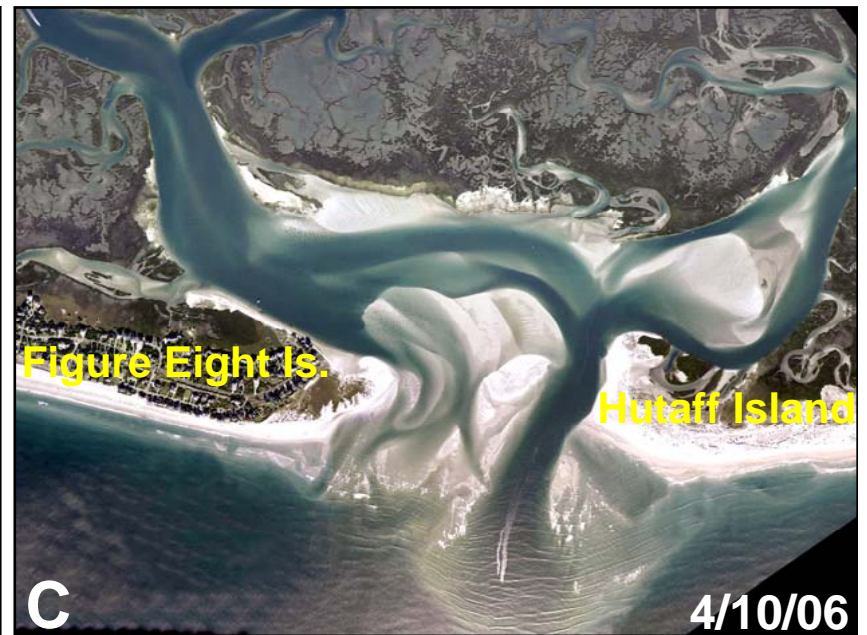
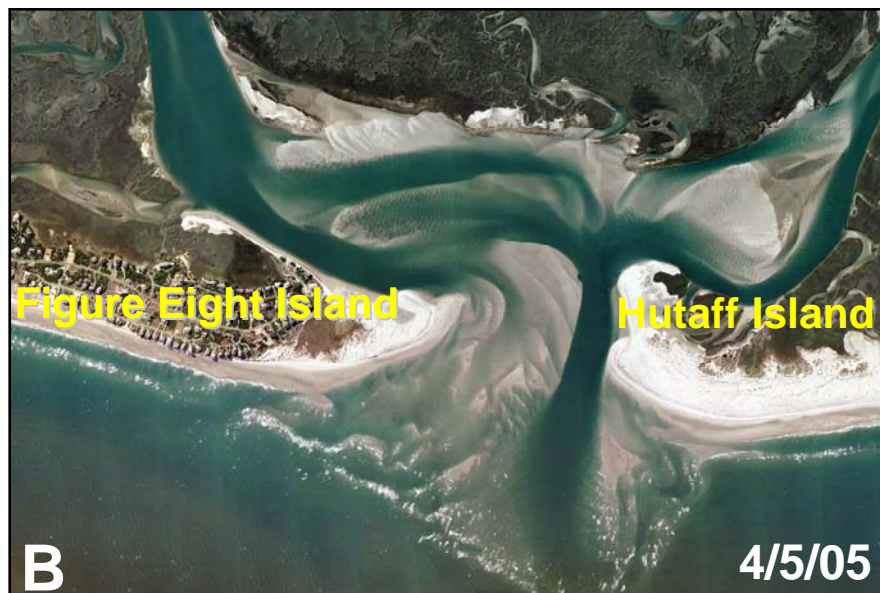
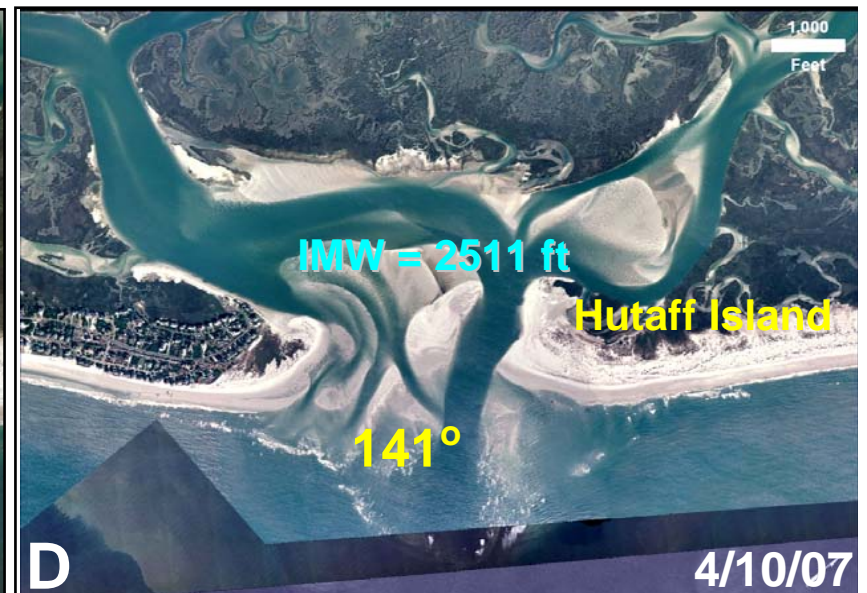
**Figure 25.** Aerial photographs (A. 10/4/04, B. 4/5/05, C. 4/10/06 and D. 4/10/07) depicting recent shoreline and inlet changes. Note the alignment of the ebb channel has remained fairly constant since 2004 while the ebb channel has shifted ~ 415 ft toward F8I (SW) since 2004.

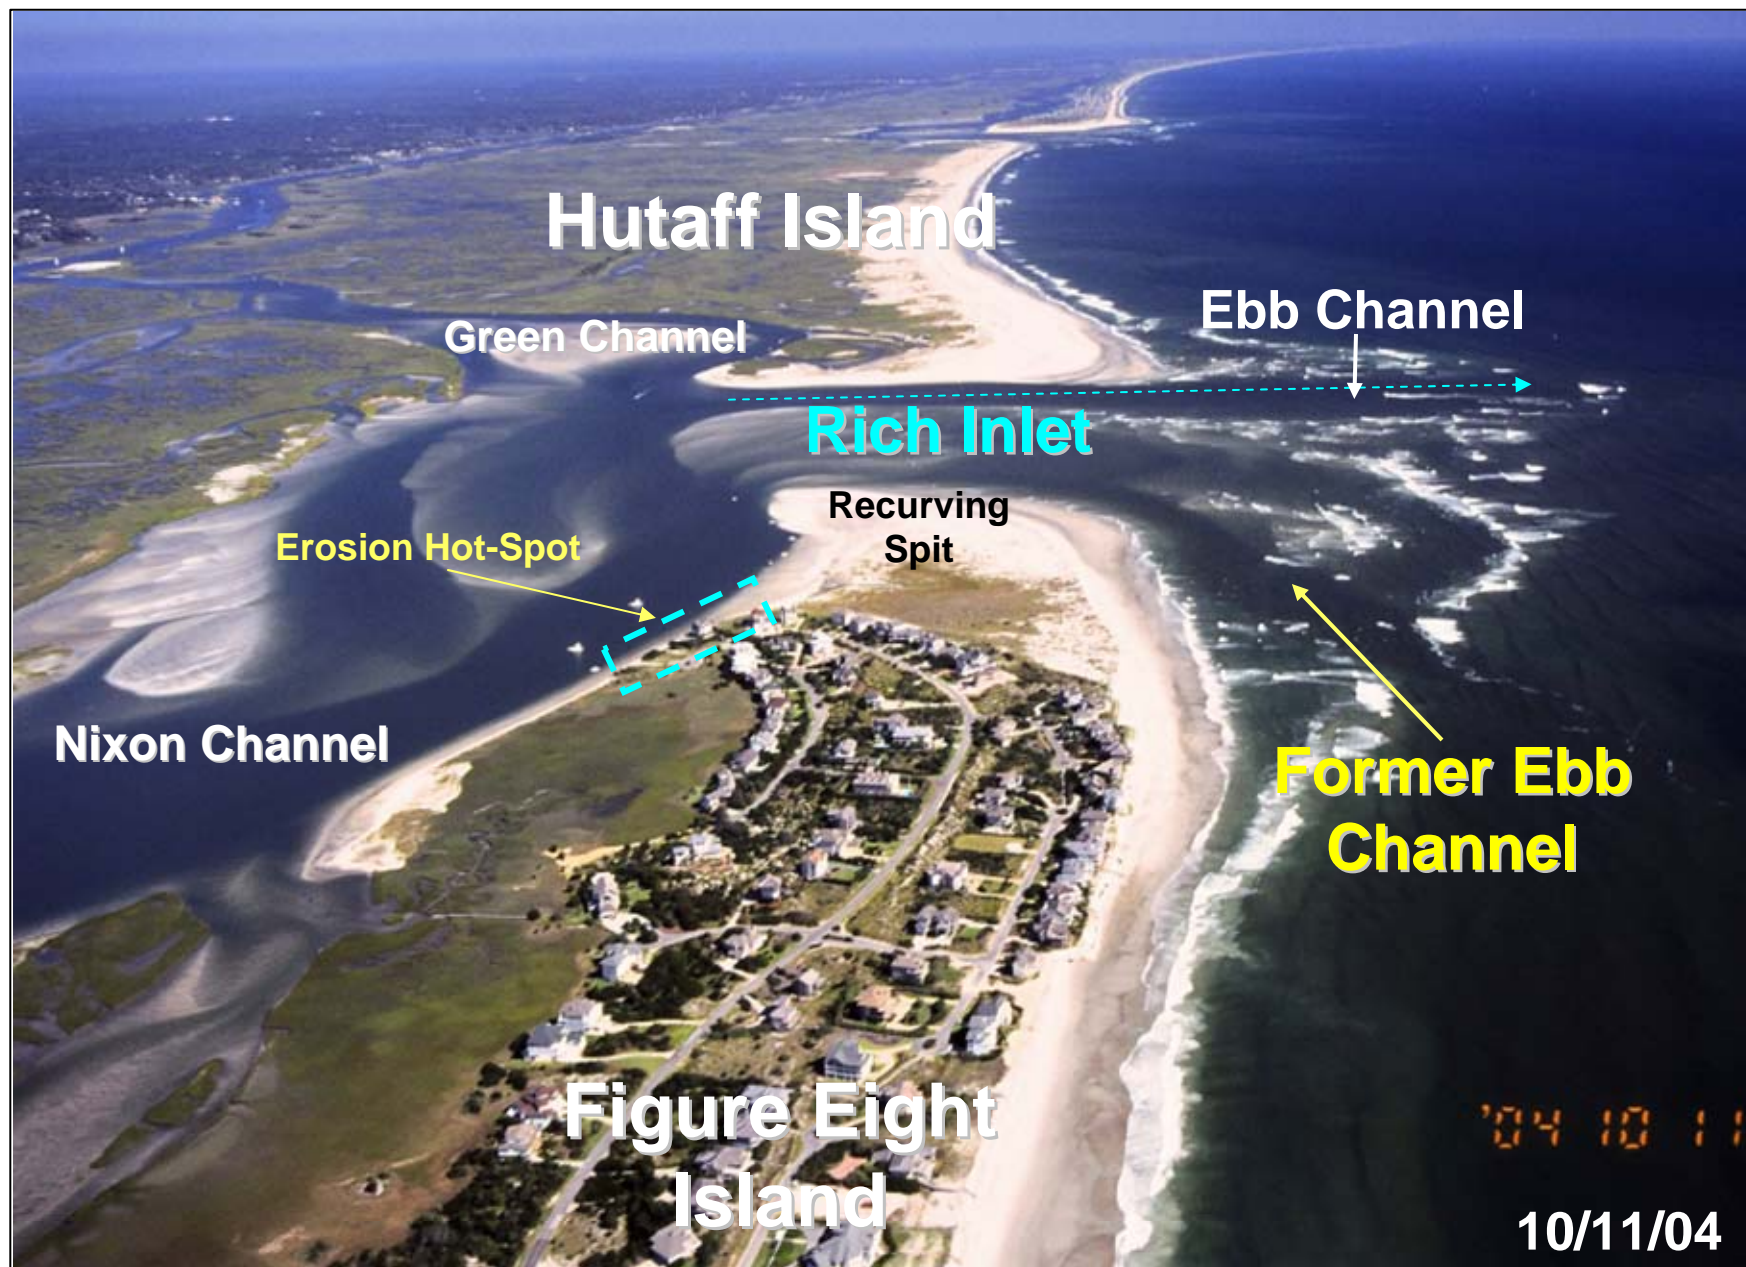
**Figure 34.** Oblique aerial photograph (10/11/04) illustrating the oceanfront conditions along northern end of F8I, the interior channels and location of the estuarine erosion hot-spot (light blue dashed line box).

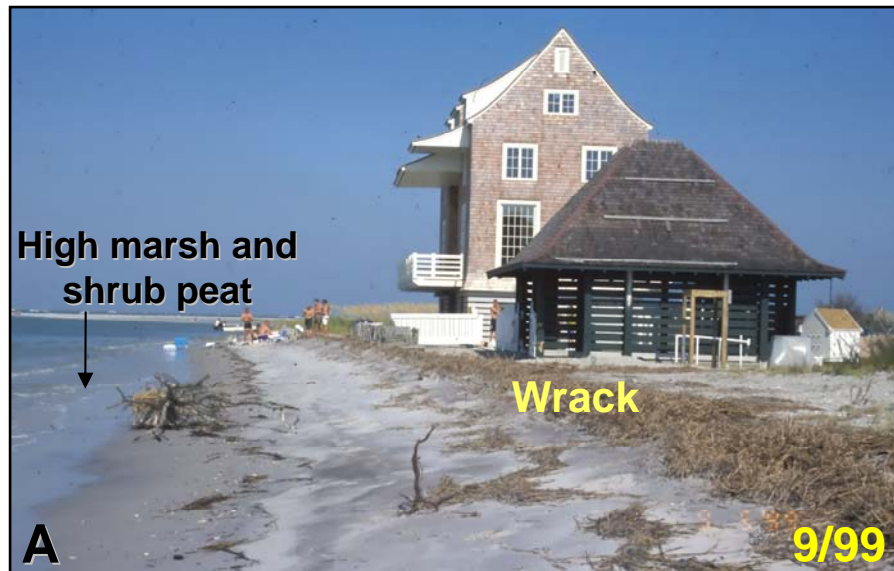
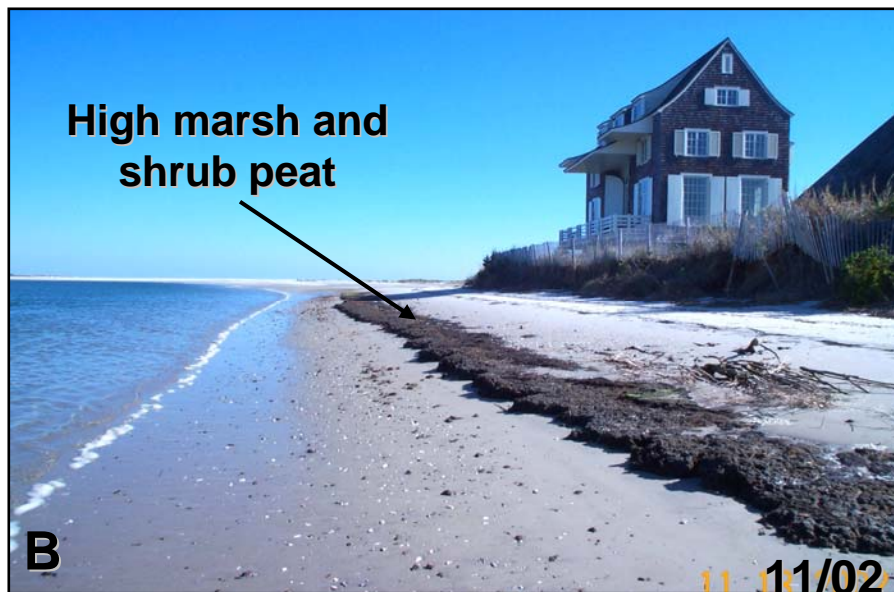
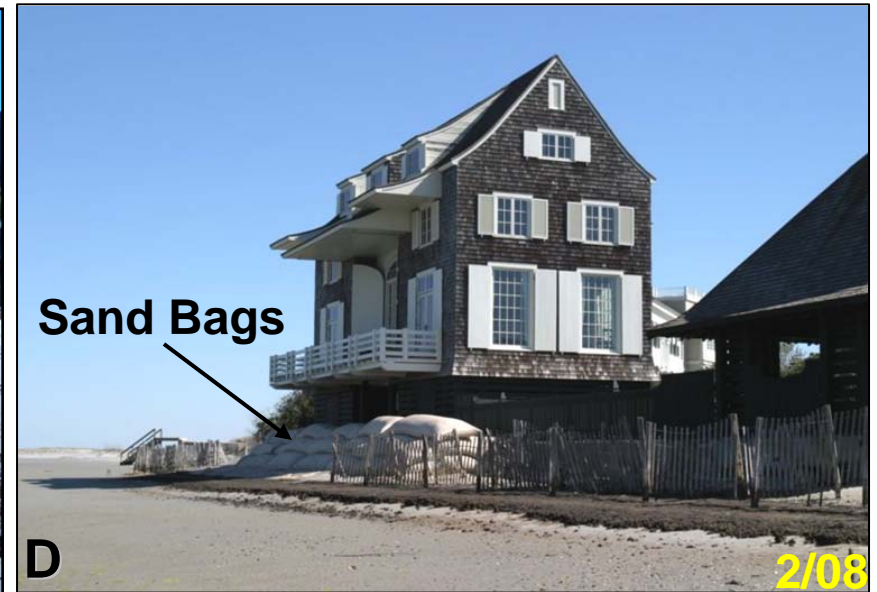
**Figure 42.** Photographs depicting erosion and shoreline retreat along Nixon Channel shoreline between 9/99 and 2/08. **A.** Seaward view (9/99) of eroding channel margin shoreline. Thin veneer of sand mantles offshore peat subcrop. **B.** Seaward view (11/02) of peat exposure and shrub stumps. **C.** Seaward view (10/06) of peat exposure and sand accumulation due to wave swash. **D.** Seaward view (2/08) of newly emplaced sand bags.

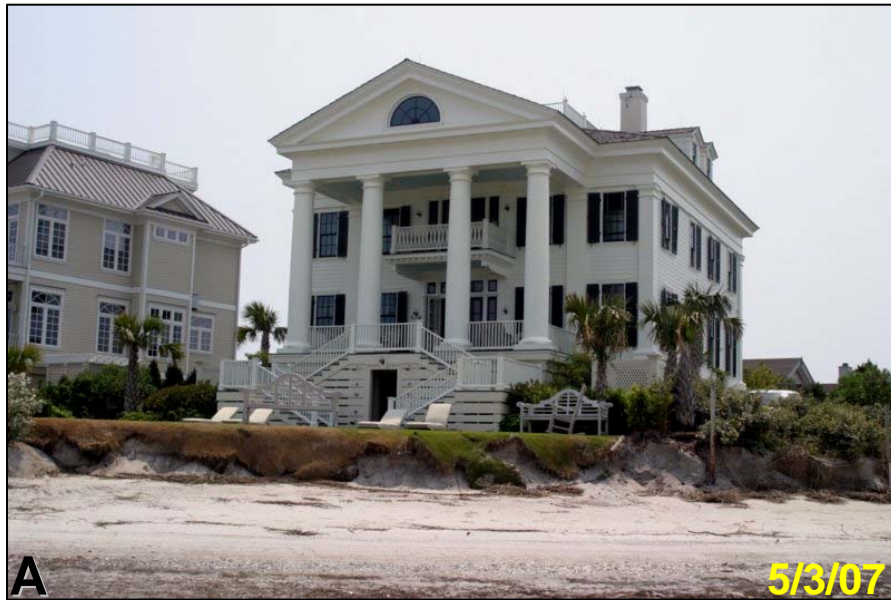
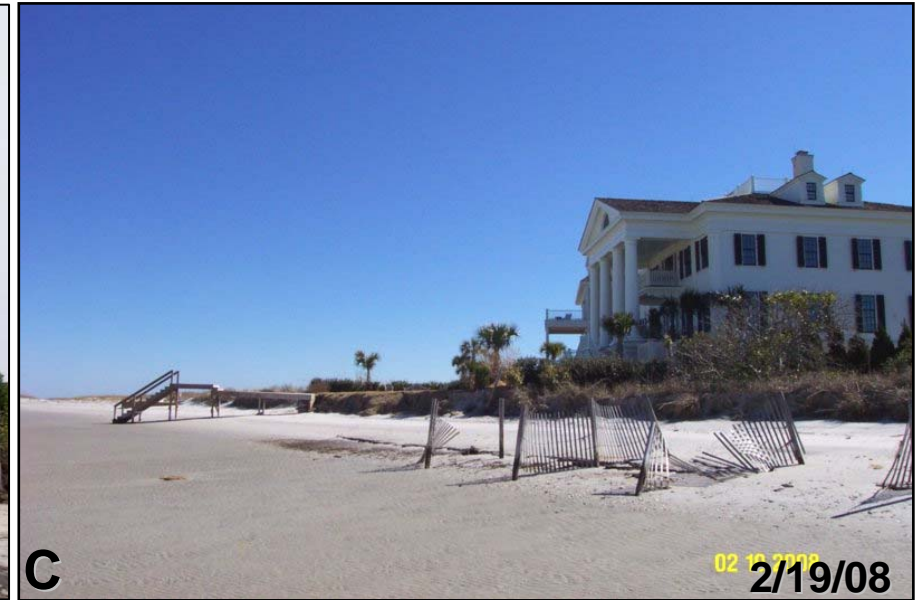
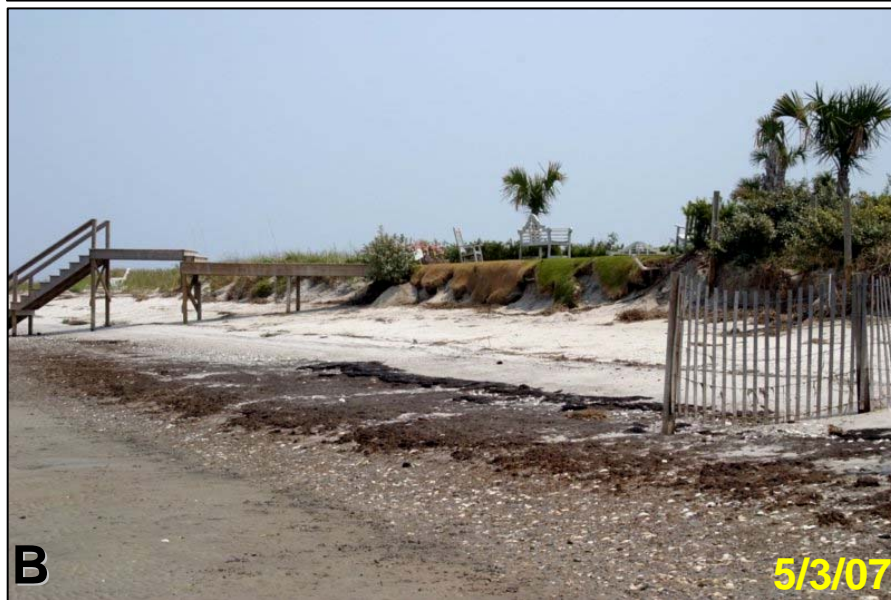
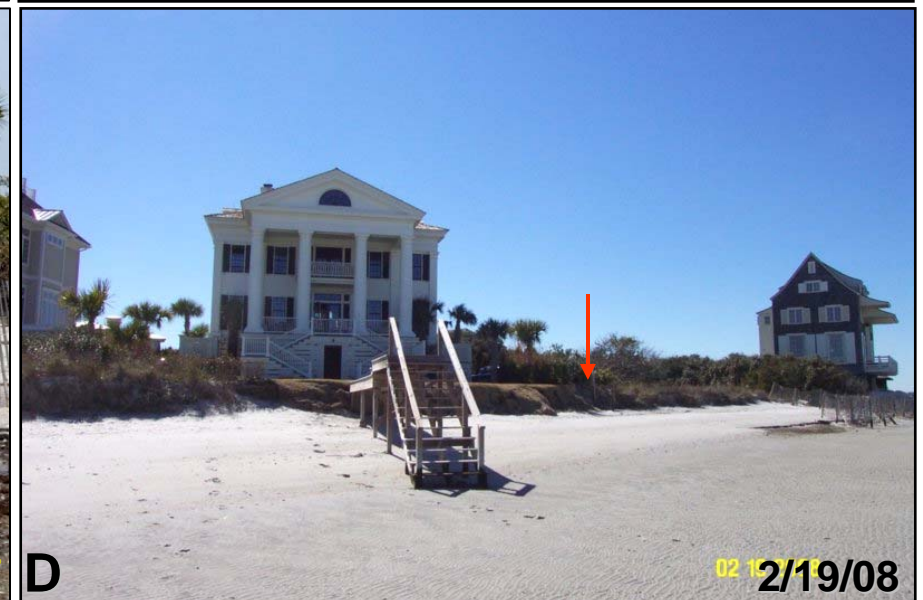
**Figure 44.** Photographs depicting erosion along a portion of the Nixon Channel shoreline. **A.** Landward view (5/3/07) illustrating erosion of the upland area. **B.** Landward view (5/3/07) of peat exposure along intertidal beach, stranded walkover and slumping of “sod”. **C.** Seaward view (2/19/08) of retreating shoreline imaged in “A” and “B”. **D.** Landward view (2/19/08) of structure in “A” and “C” and small scarp (red arrow) that extends toward adjacent home that is fronted by sand bags and a peat exposure.
